Re: February 2012 Monthly Progress Report  
Administrative Settlement Agreement and Order on Consent for Removal Action  
U.S. EPA Region 10 Docket No. CERCLA 10-2009-0255  
Gasco Sediments Site within the Portland Harbor Superfund Site

## Visual Observations Log Form

**Monitoring Period:** Monthly (Year 6)—February 2012

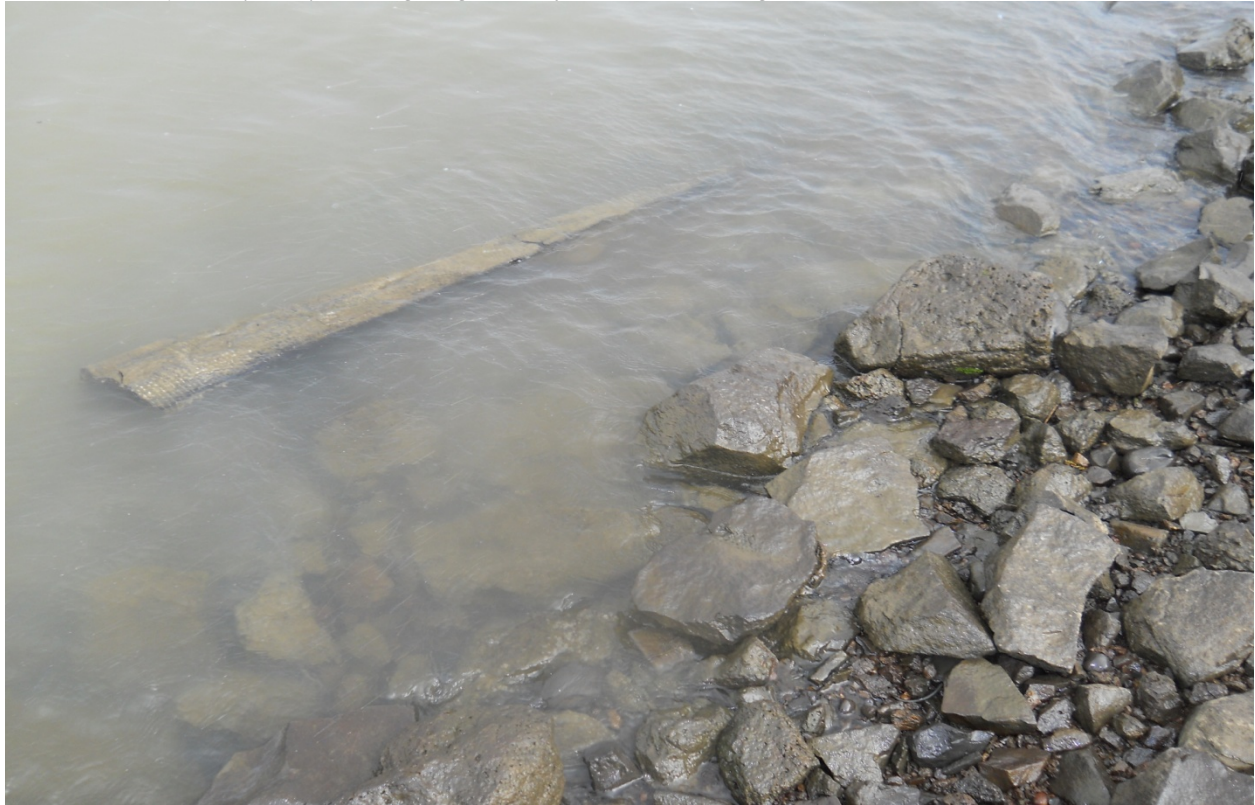
**Observations of Erosion/Deposition:** No erosion/deposition is evident along the shoreline. One four-foot long organoclay mat material segment was exposed and visible in approximately one foot of water (Photo 1). The extents of the remaining organoclay mat material footprint was submerged due to high river water elevation.

Photo 1— *Exposed, four- foot long, organo clay mat material segment (2/22/12):*

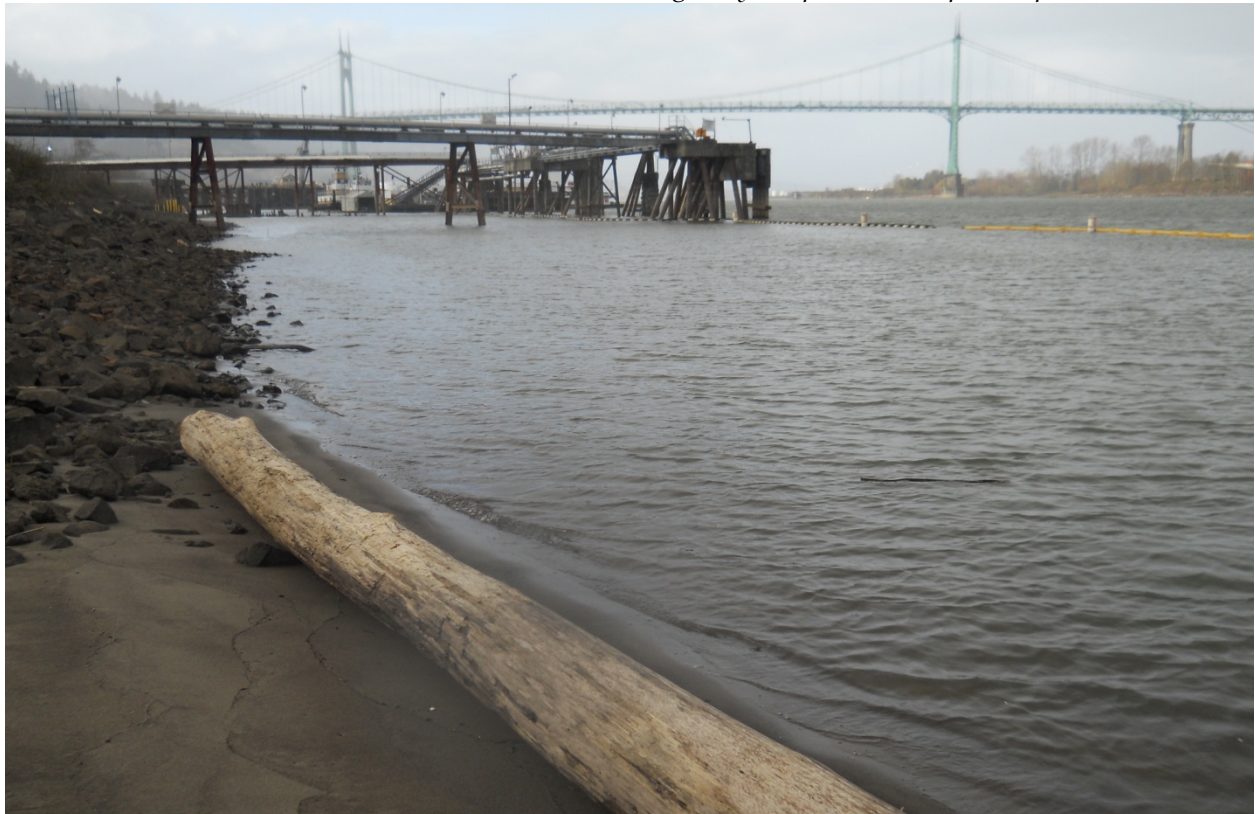
**Observations of Long-term Controls (i.e., oil booms, organo-clay mat, etc.)** During the observation, the Fuel and Marine Marketing (FAMM) containment boom was in place across the cap area, between the upriver corner of the ship dock and the wooden dolphin (near the upriver extent of the site and near the Siltronic Corporation outfall. Buoys that identify the cap area to mariners are in place as installed. The position of the FAMM oil boom, warning buoys, and a general overview of the site shoreline is shown in Photo 2.

Photo 2 — *FAMM oil boom shown and mariner warning buoys in place across pilot cap area. (2/22/12):*

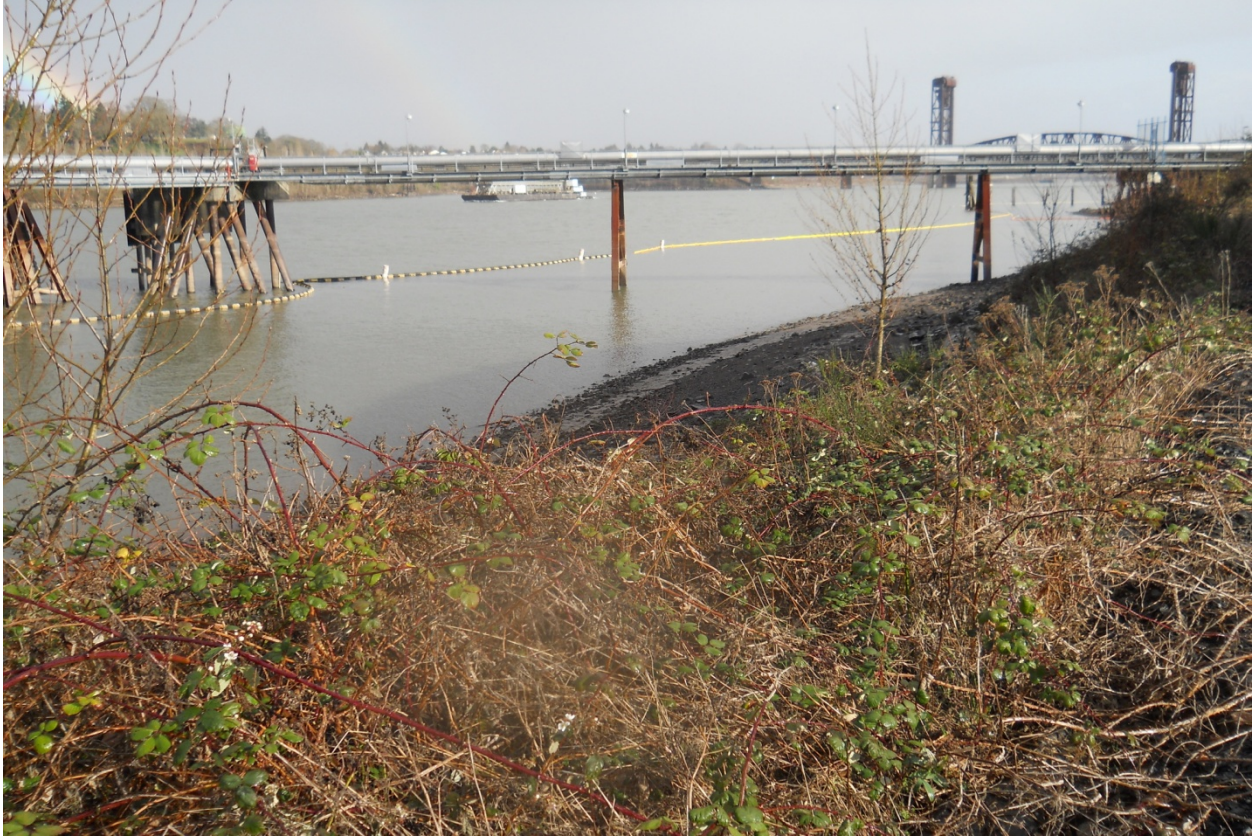
**Other Comments:** No sheen is evident in or around the cap area. Photo 3 shows the water surface and shoreline immediately downriver of the sediment cap.

Photo 3 — *Conditions immediately downriver of cap area (2/22/12):*
